YOUR Inspection Report

58 California
Chicago, IL

Tuesday, September 23, 2008

RE: Report No. 1829
58 California
Chicago, IL

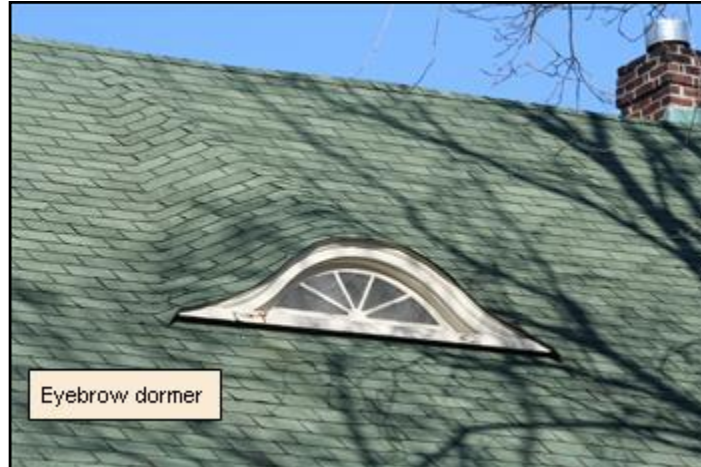
1. Asphalt roofing with decorative dormer

Probability of leakage: • Medium

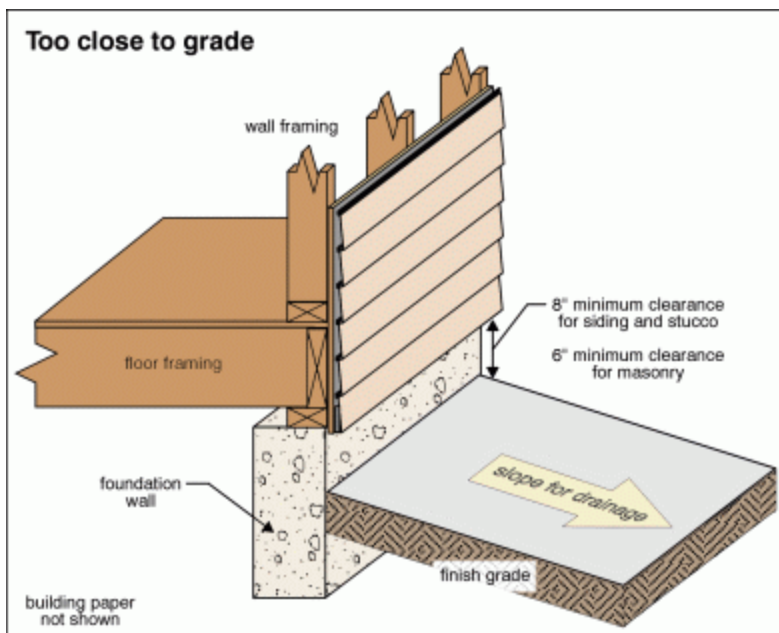
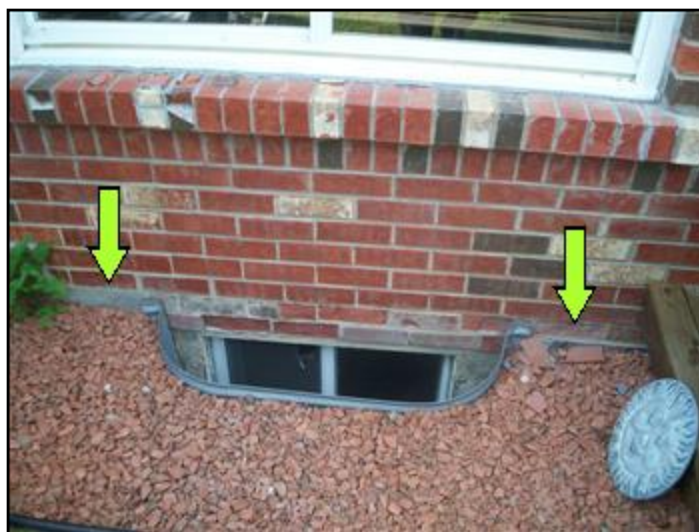
Condition: • [Too close to grade](#)

Implication(s): Chance of water entering house | Weakened structure | Rot

Location: Right side

2. Brick should be 6" above grade

Note: Grade should be lowered to keep brick 6 inches above the ground.

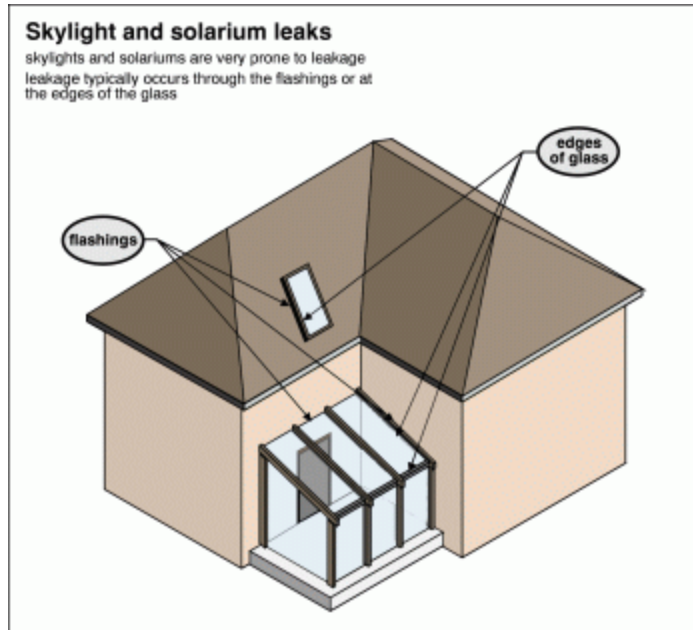
Condition: • [Leak](#)

Implication(s): Chance of water damage to contents, finishes and/or structure

Location: Rear Third floor

Note: Evidence of water damage and staining noted. Skylights on west slope are designed to be opened but are secured closed with a locking plate.

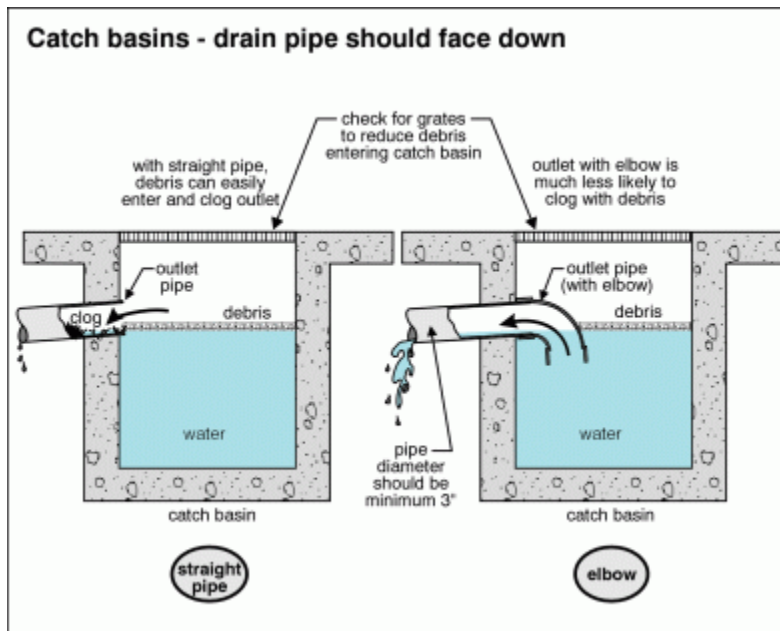
Condition: • [Clogged catch basins](#)

Implication(s): Chance of water damage to contents, finishes and/or structure

Location: East

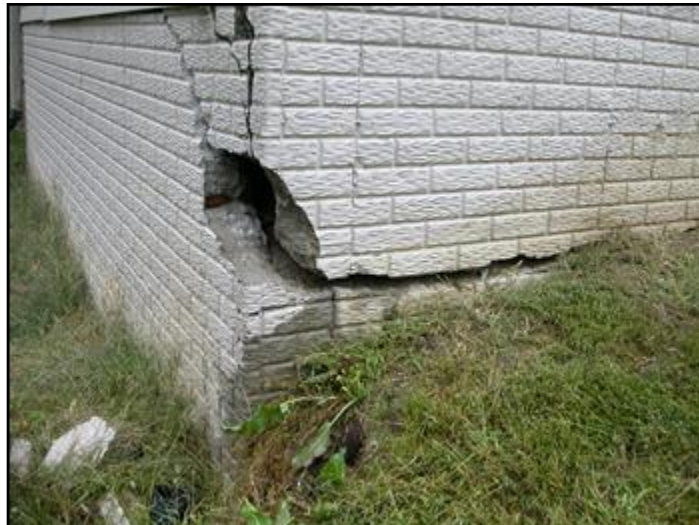
Condition: • The foundation at the rear of the home has failed, apparently as a result of unstable soil on the sloped lot. A soils specialist should be engaged to determine whether the building can be stabilized.

3. Failed foundation

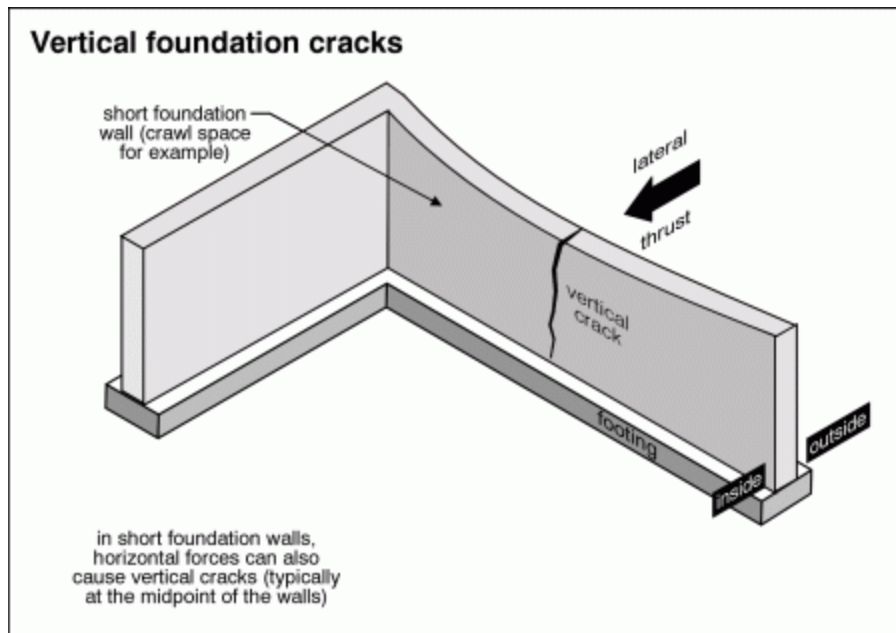
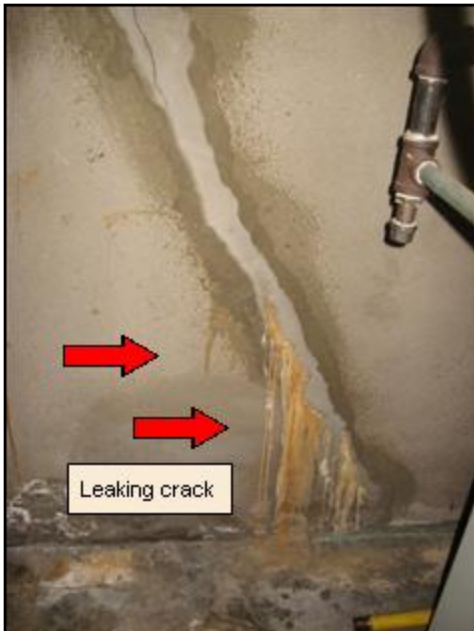
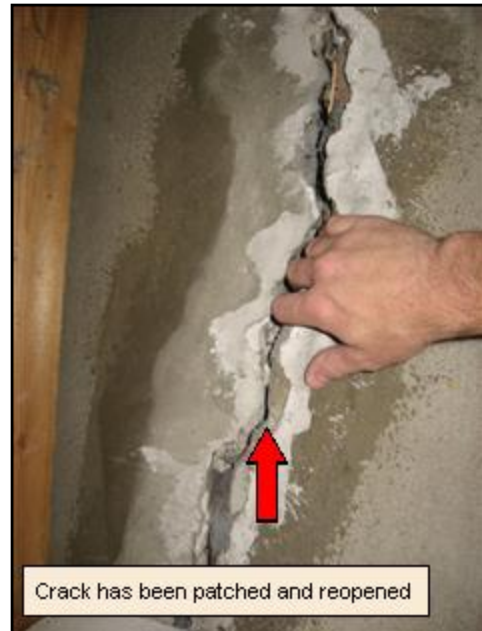
Condition: • [Cracked](#)

Implication(s): Chance of water damage to contents, finishes and/or structure | Weakened structure

Location: Left side Basement

Note: Severe cracking of the foundation wall was noted. It appears that movement is ongoing, since the crack has been patched at least once, and had reopened. The crack was leaking actively at the time of the inspection, although leakage is not the main concern. The building footing appears to be shifting, and needs to be stabilized. This is a high priority repair.

4. Foundation crack - leaking

5. Cracked foundation wall

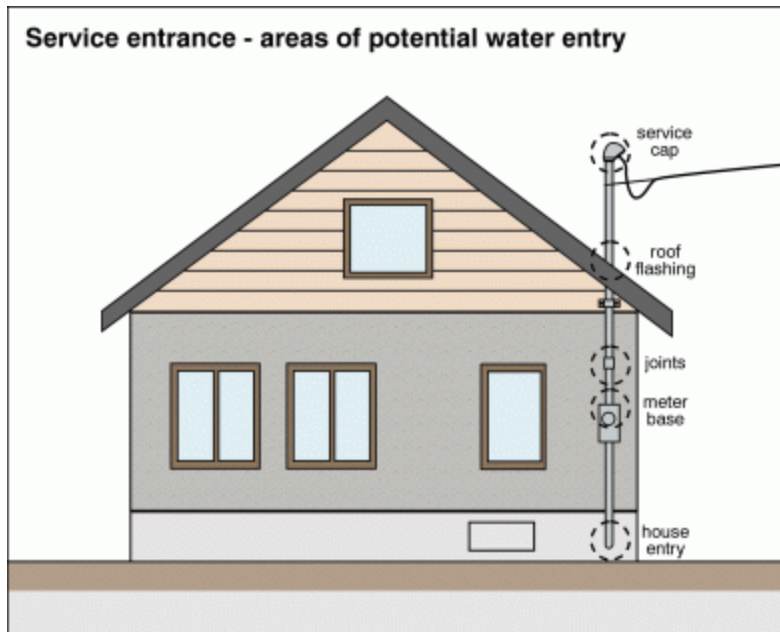
Condition: • [Rust or water in panel](#)

Implication(s): Electric shock | Fire hazard

Location: North Basement

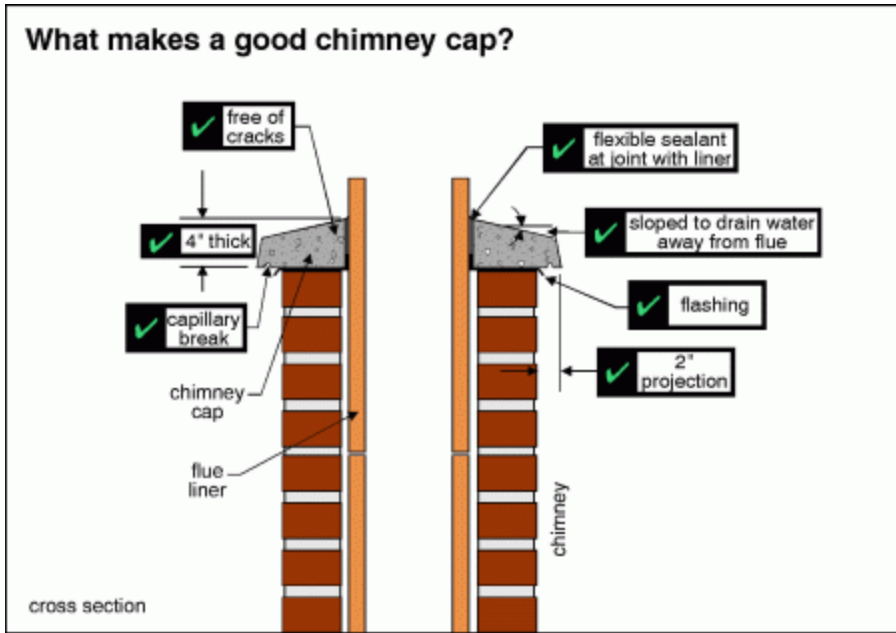
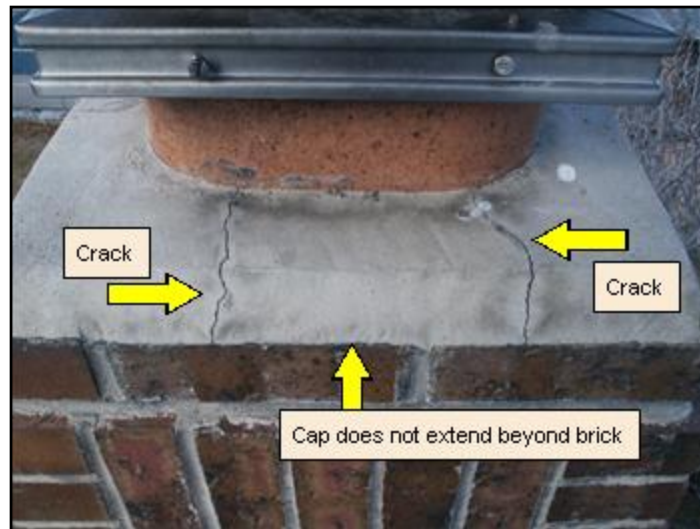
Condition: • [No drip edge on cap](#)

Implication(s): Chance of water damage to contents, finishes and/or structure | Shortened life expectancy of material | Material deterioration

7. Chimney cap issues

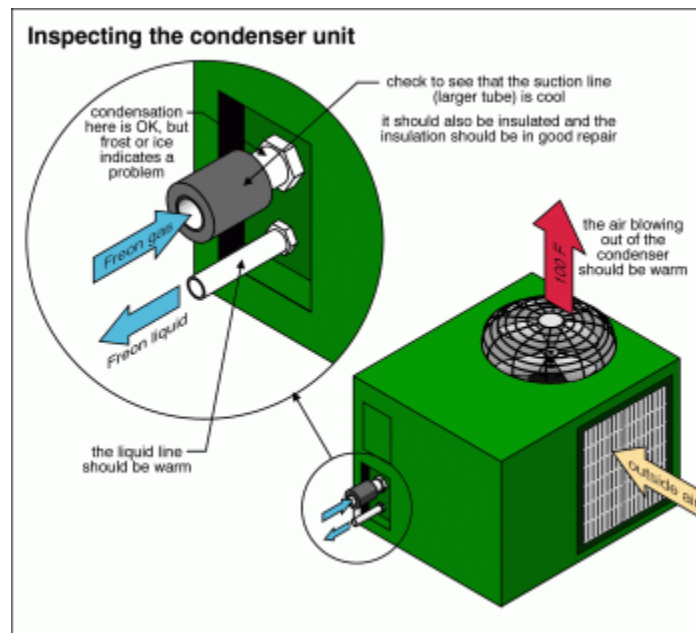
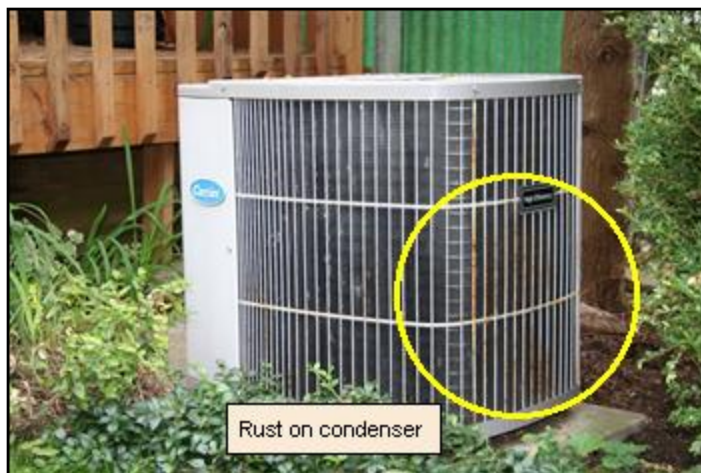
Condition: • [Corrosion](#)

Implication(s): Reduced system life expectancy | Equipment not operating properly | Increased cooling costs | Reduced comfort

Location: Rear Exterior

8. *Rusted condenser*

Note: Rust on the air conditioner does not require immediate action, although this should be checked during annual servicing.

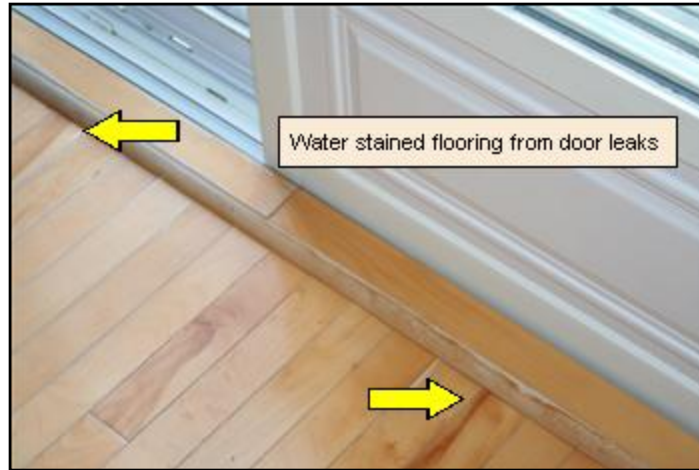
Condition: • [Stained](#)

Location: Kitchen

9. Stained flooring

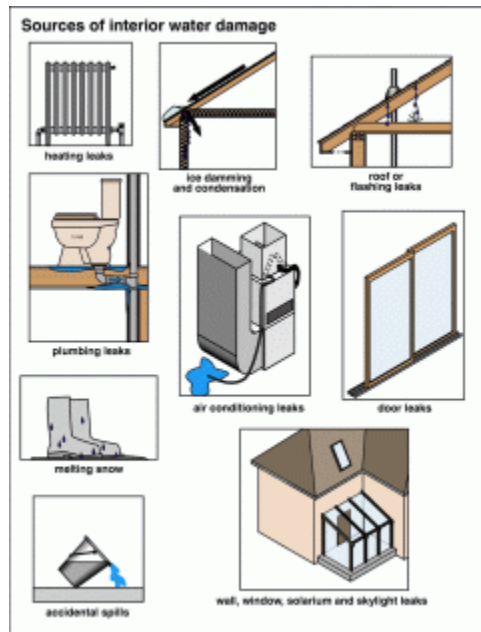
Condition: • [Water damage](#)

Implication(s): Cosmetic defects

Location: Rear Second floor Bedroom

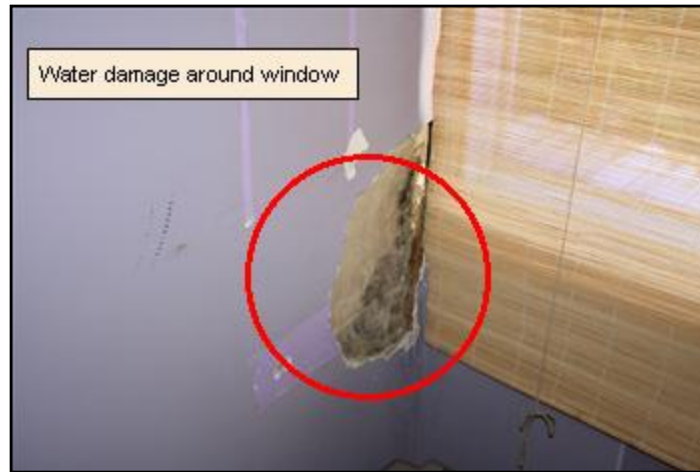
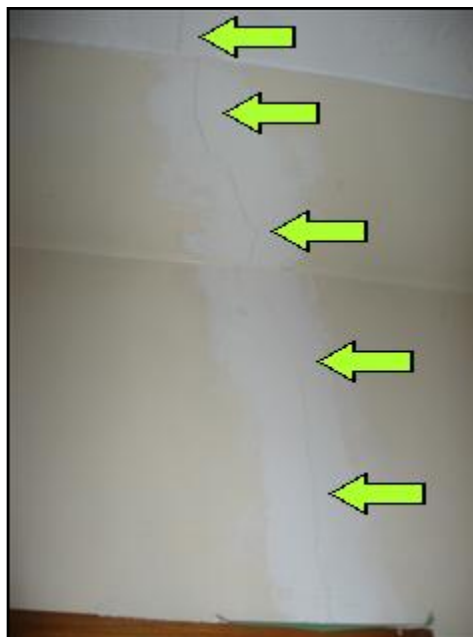
Condition: • [Cracked](#)

Implication(s): Cosmetic defects

Location: Northeast Dining room

11. Wall and ceiling cracks
